Macroseismic investigation of Jaisalmer earthquake of 9th April 2009

By Rajendra Sanwal
S.K. Kulshrestha

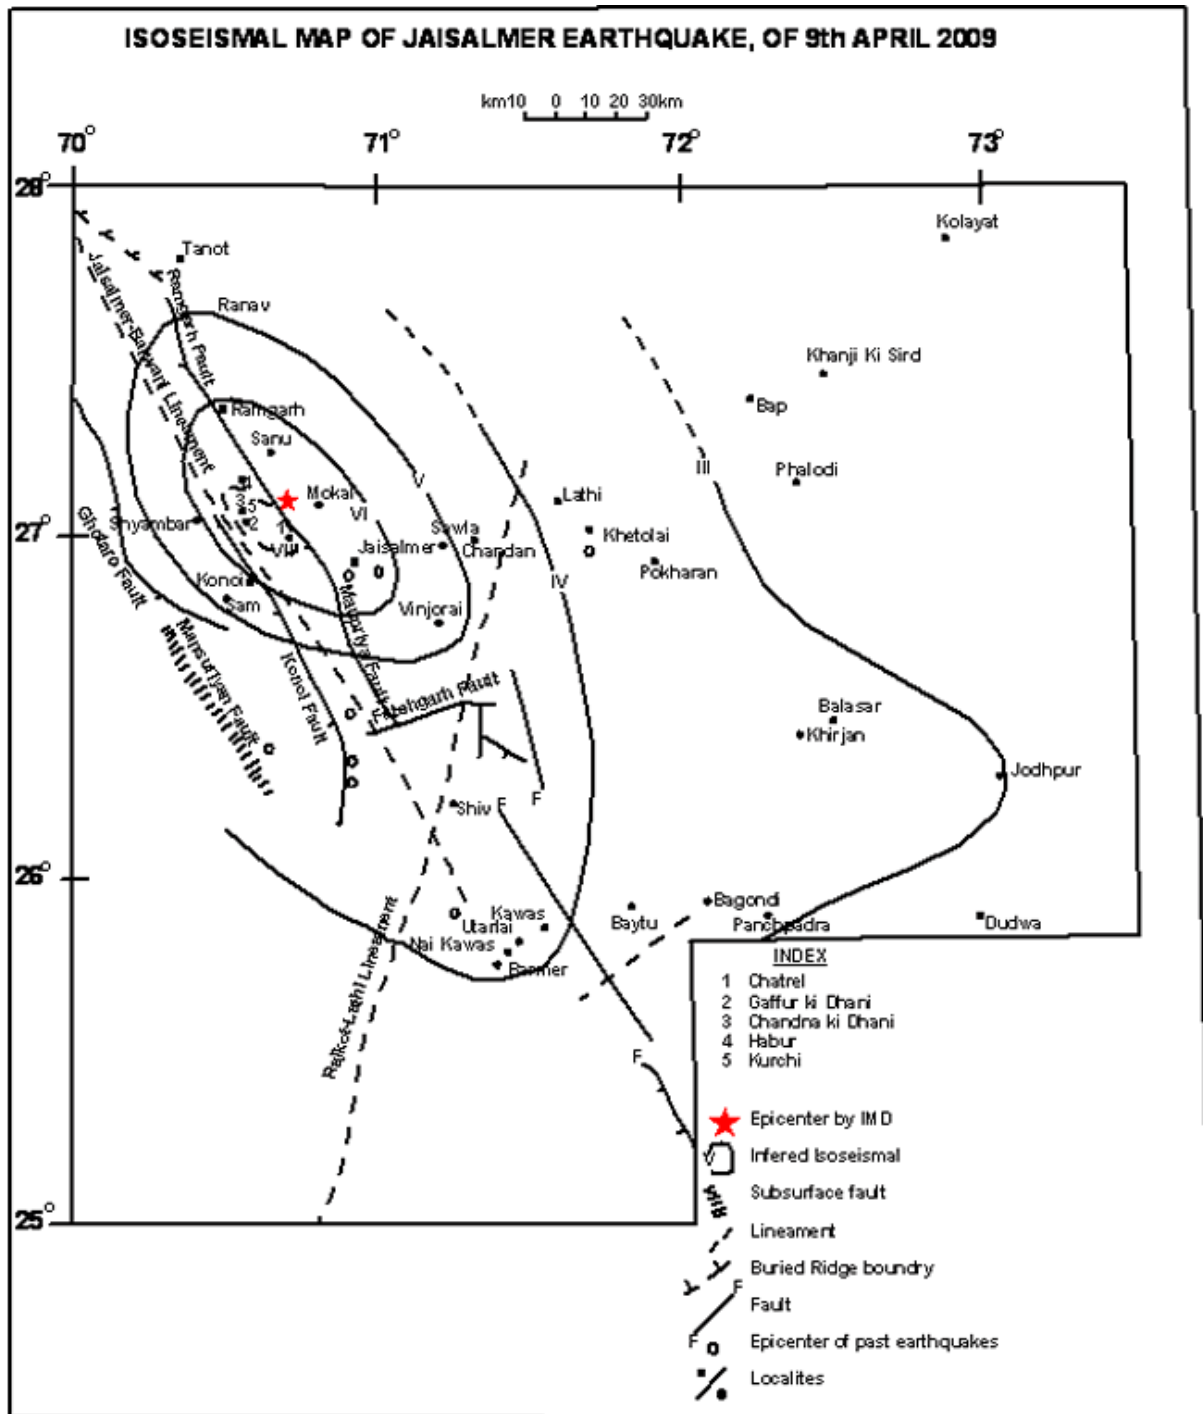
Based on the ground validation, particularly on human perceptibility, isoseismals have been drawn by following the MSK-64 intensity scale. Maximum intensity interpreted is VII around villages Chandna – ki – Dhani, Gafoor – ki- Dhani and Kurchi area. The meizoseismal zone encompassing an area of 400 sq km lies on the western proximity of instrumentally recorded epicentre at Mokhal.

The plot of the isoseismals indicates that Isoseist VI aligned almost NW-SE, similar to isoseist VII and encloses an area of about 2600 sq km. Important localities in this isoseist are Jaisalmer town, Lanela, Mokal, Sanu, Ramgarh, Habur, Damodra, Lodarva, Kanoi, Shyambar, etc. Most people felt the shock and got frightened. Domestic animals ran outdoors and birds started chirping. Many buildings of Type B, in Jaisalmer and Ramgarh developed grade 2 cracks, prominent being RTDC Guest House / Hotel, Gaffor Batta, PWD office and Guest House, Girls School, Circuit House, Railway Station, etc. In Kishnai Devi Mangi Ram Girls Higher Secondary School (Jaisalmer), physics lab building was the worst affected where a portion of four walls and floor got separated from the building, with openings of 2-4 cm across the wall. The grade IV damage in this type B structure completely disturbed the cohesion of the building.

Figure 1: Isoseismal Map of Jaisalmer Earthquake 9th April 2009

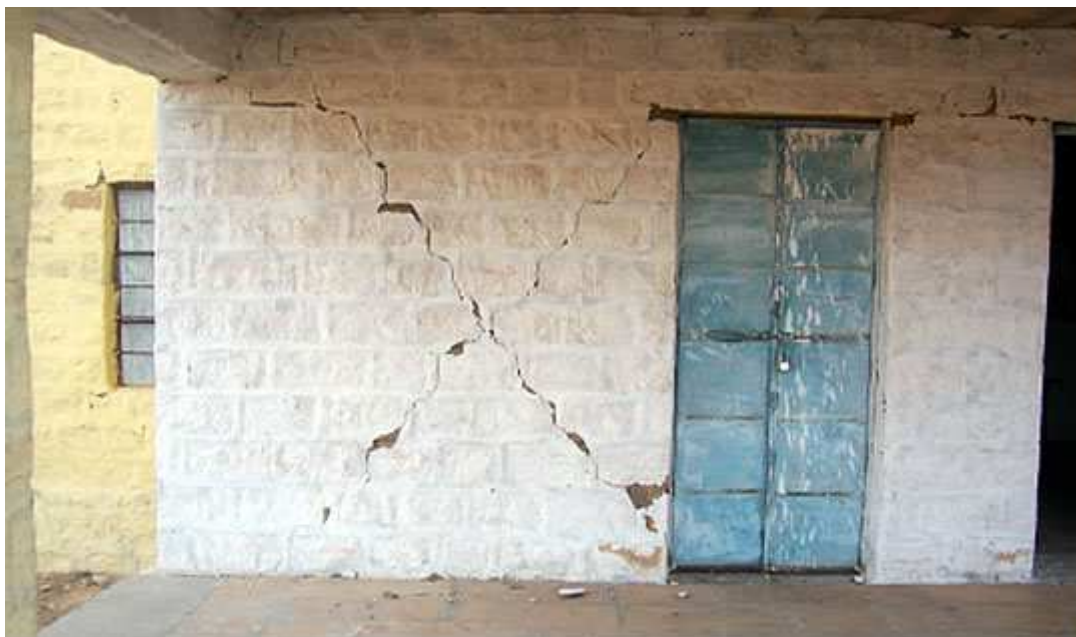
In isosiest VII, most people got frightened and ran outside, some even lost balance. Most houses of Types A and B developed cracks of grade II and I. In Chandna-ki-Dhani, 21 houses of Type B got fully damaged while 3 were severely damaged. In many houses, like school building in this village, wall cohesion was almost lost. In Anganbari building of Kurchi village the load bearing E-W wall failed and the steel

Figure 2: Conjugate joint in wall of School building in Chandan-ki-Dhani

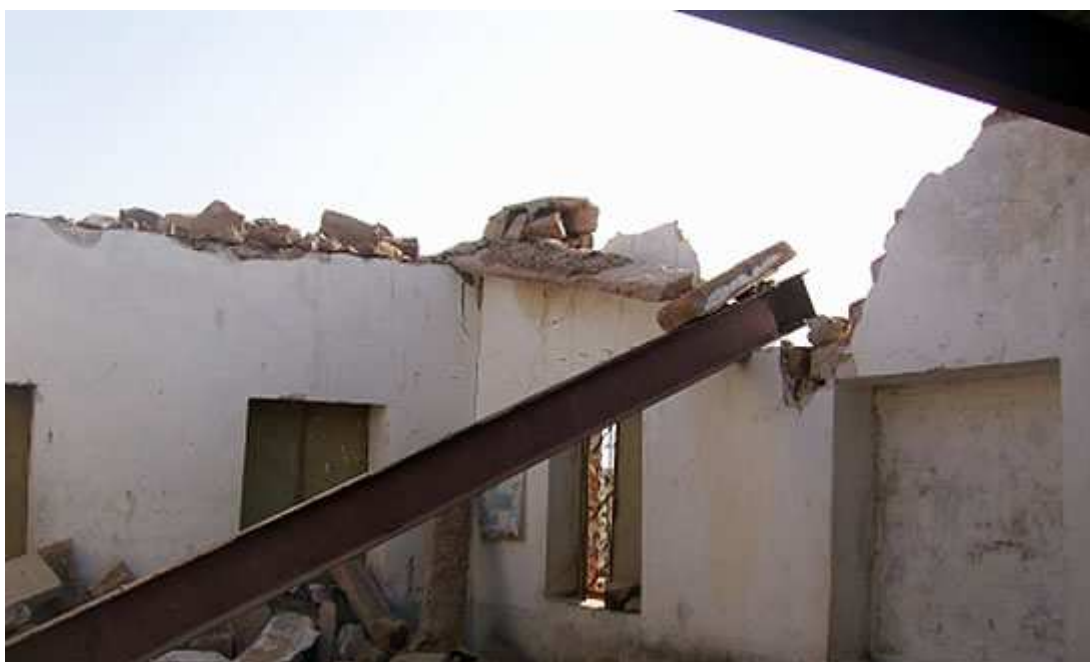
support on the ceiling fell. Partial collapse of Old Bhurj (Fort) in Salka and a few houses in Kurchi, Chetral (eastern wall), etc., were observed. In Gafoor – ki- Dhani and Chandna-ki-Dhani, ‘sand blow’ was reported. Possibly, the entrapped air got ejected out and was accompanied by a characteristic sound, which perhaps gave the illusion of gas eruption.

Figure 3: Failure of load bearing E-W wall of Anganbari building in Kurchi village

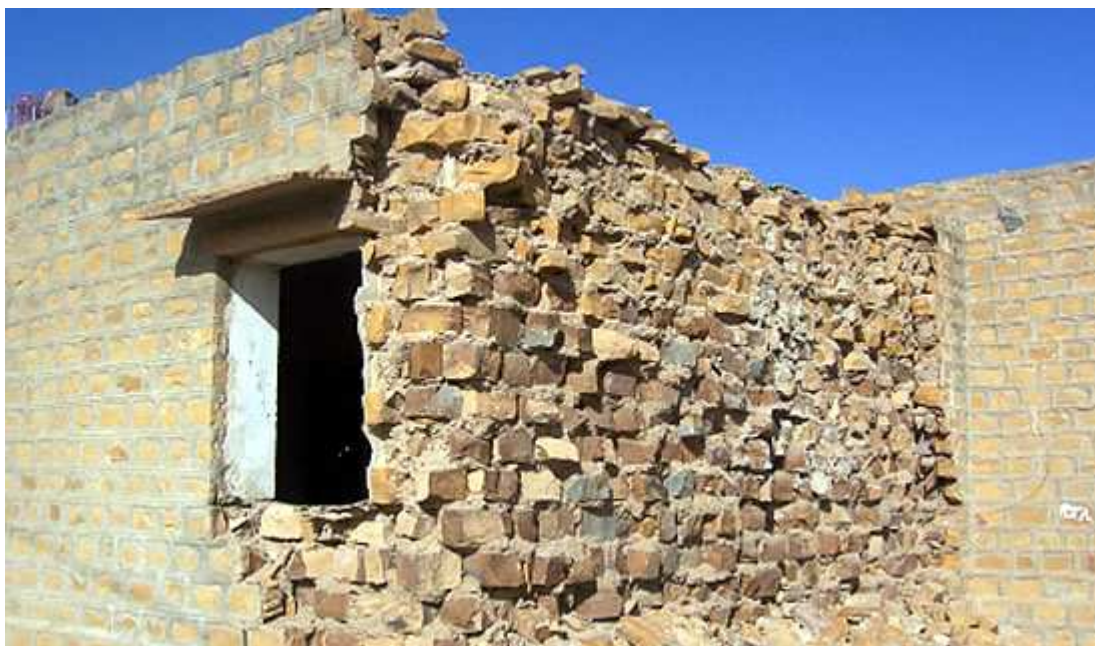
Figure 4: Partial collapse of wall of a school building in Mokhal

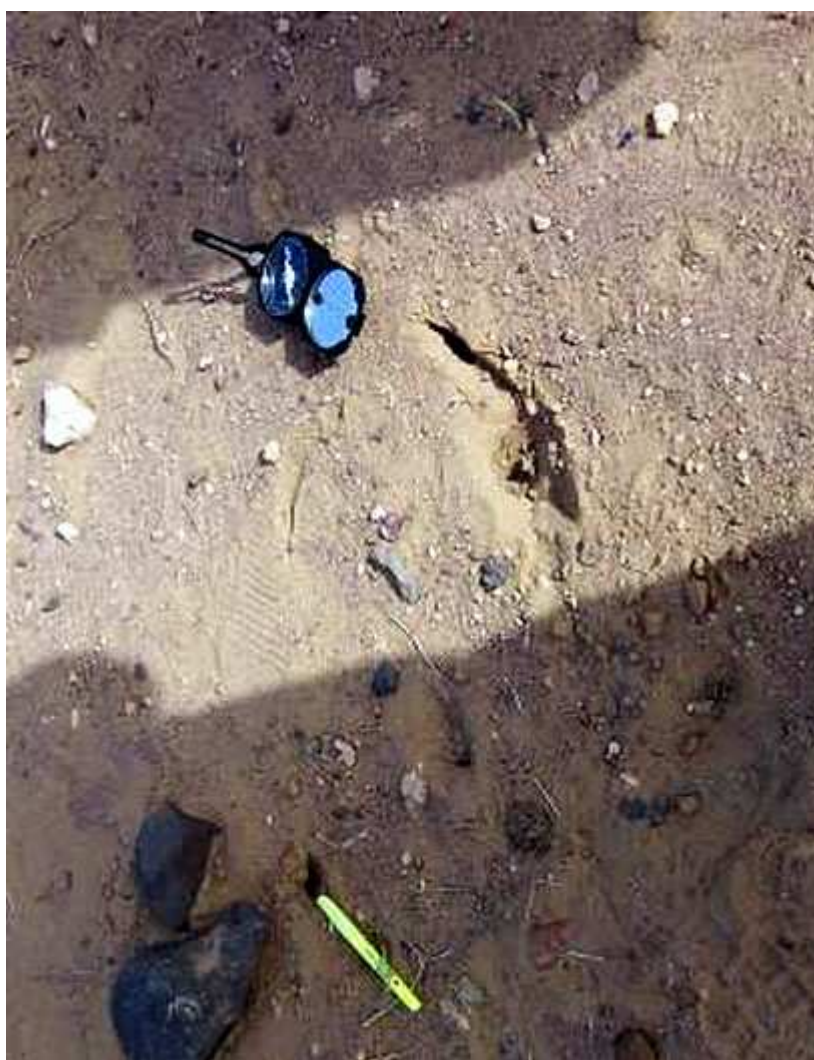
Figure 5: Inverted cone like cavities formed due to escape of trapped air during tremors in Gafoor-ki-Dhani.

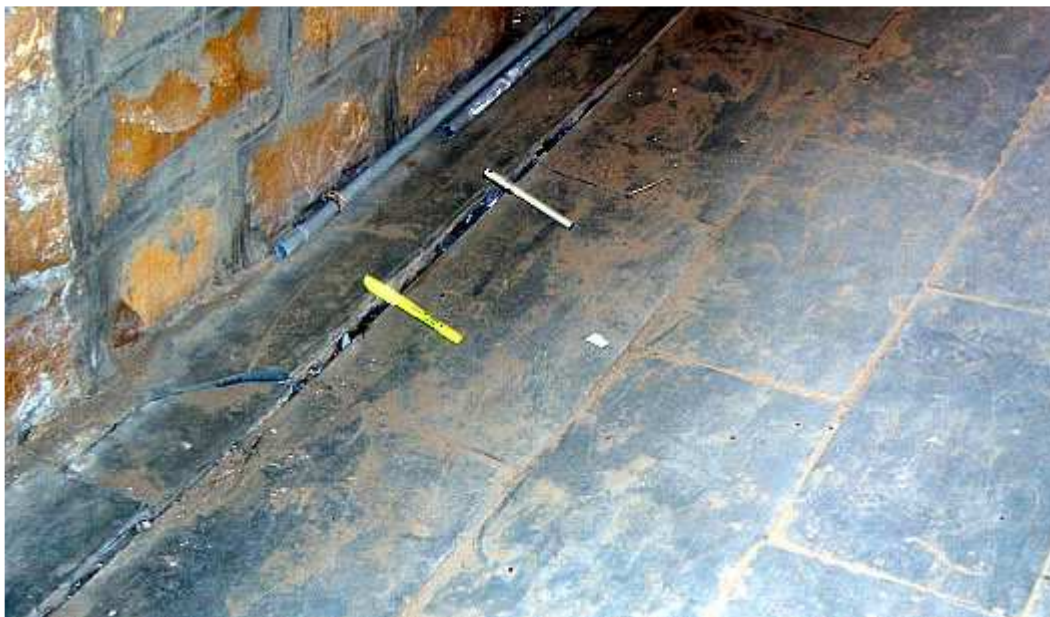
Figure 6: Subsidence in the floor of Kishnai Devi Mangi Ram Girls Higher Secondary School

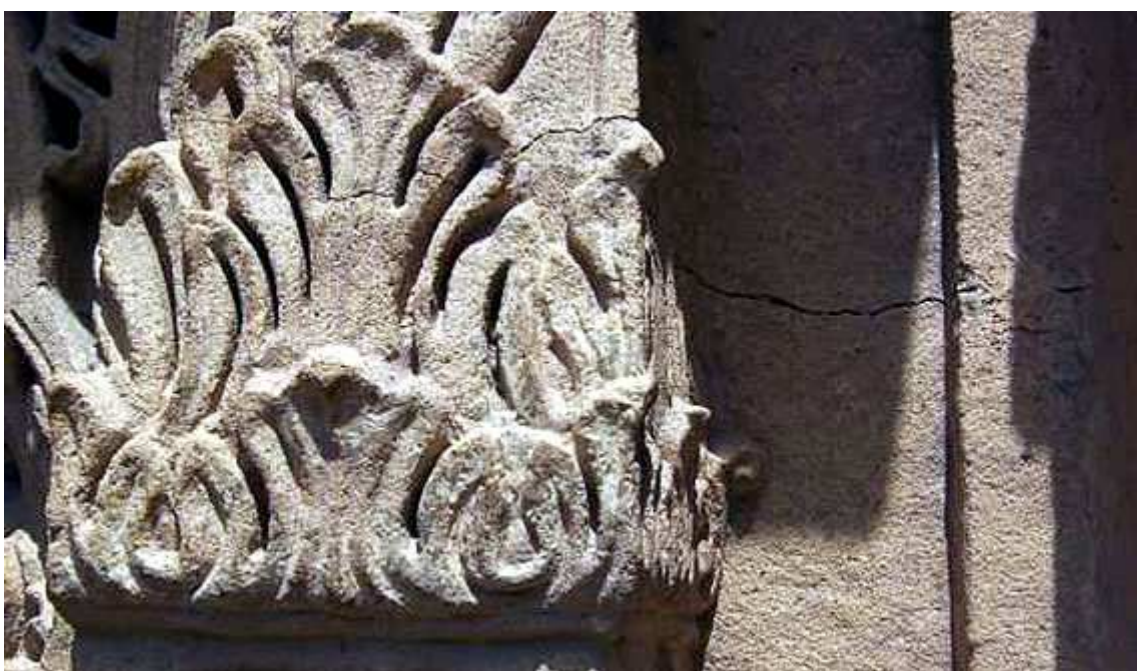
Figure 7: Horizontal cracks developed in pillar of Jain temple Amar Sagar, Jaisalmer

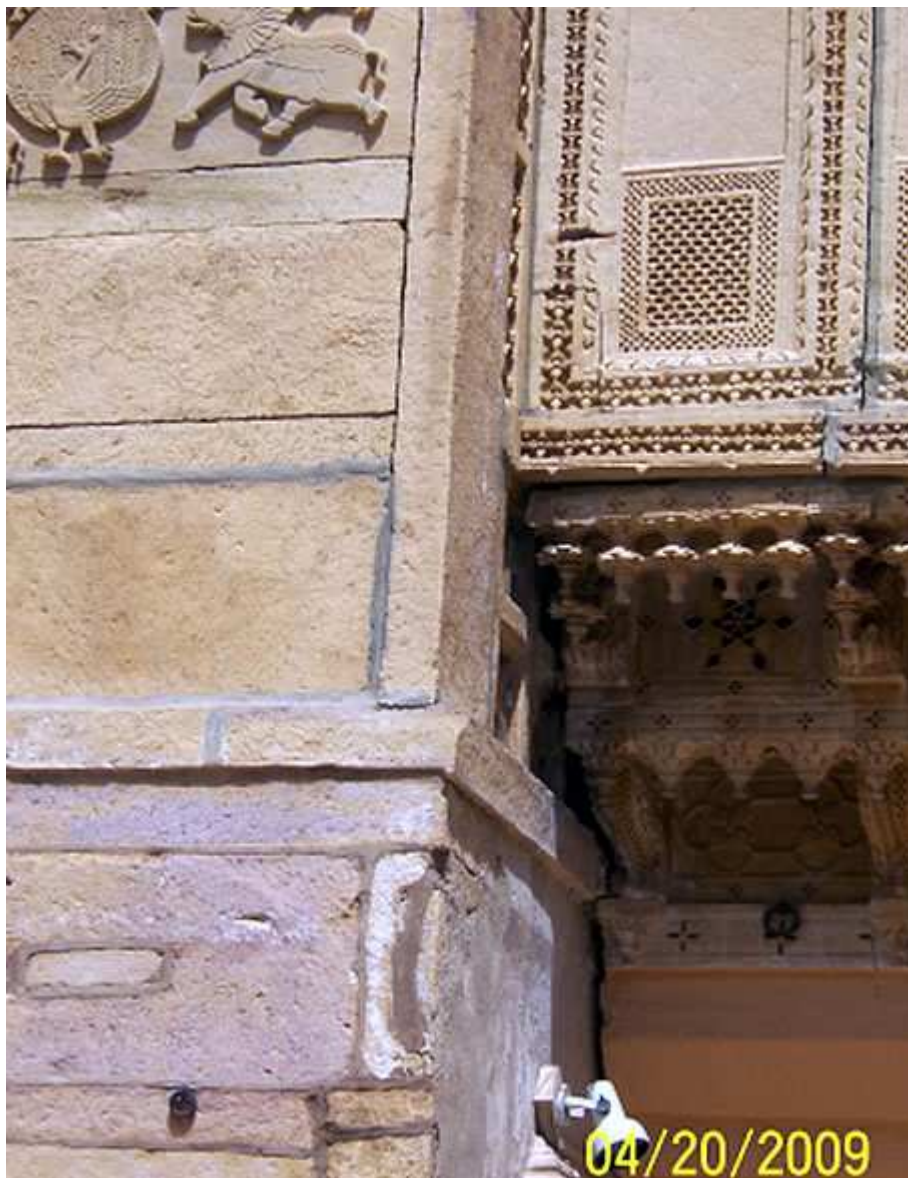
Figure 8: Opening of Joint in Jaisalmer fort
